SUBJECT: 6.0 L Injector Stiction Discussion and Recommendations

[Alliant Power Tech Bulletin APTB 01/09](#)

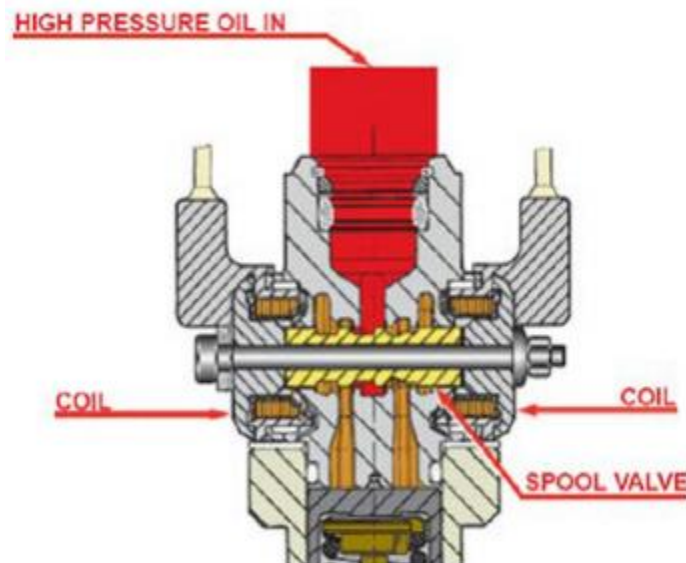
6.0 L Injector Spool Valve Operation (refer to Figure 1) The spool valve is located in a bore in the stator housing; coils and coil housings positioned on both ends of the stator housing serve as end caps to seal the assembly and limit spool valve travel (0.432 mm). An open coil on one side of the stator housing and a closed coil on the other are alternately energized during engine operation to move the valve horizontally. The spool valve has two positions-movement of the valve positions the valve over drillings in the stator housing which either (1) allow high-pressure oil from the oil rail into the injector high-pressure oil pumping chamber, or (2) allow pressure in the high-pressure oil chamber to collapse and oil to exhaust from the injector. Open coil energization allows high-pressure oil into the high-pressure oil pumping chamber; close coil energization allows oil to exhaust from the pumping chamber; when neither coil is energized, the valve will remain where it was last positioned (in Figure 1, below, the close coil is shown on the left side, and the spool valve is in the closed position; also note the gap between the spool valve and the open coil on the right side).

As applied to 6.0 L Injectors, the term is used to describe the condition when static friction (i.e., stiction), in addition to normal static inertia, is greater than the force of either injector coil, resulting in a delayed spool valve response or a stuck spool valve. Stiction can be either a momentary or permanent condition, but is most often momentary. Because the spool valve is operating in an

engine oil environment, stiction is usually temperature related increased oil viscosity as a result of cold temperature will exacerbate stiction causing conditions, leading to an increase in stiction severity; decreasing oil viscosity as the engine warms up often leads to a decrease of cessation of stiction symptoms.'
